SOVENT

A Brief Overview of Sovent Sewer Stack Systems,
their Issues and Blue Works Un-Matched Results
in Returning Sovent Piping to Original Operating
Condition with the Least Destruction Required

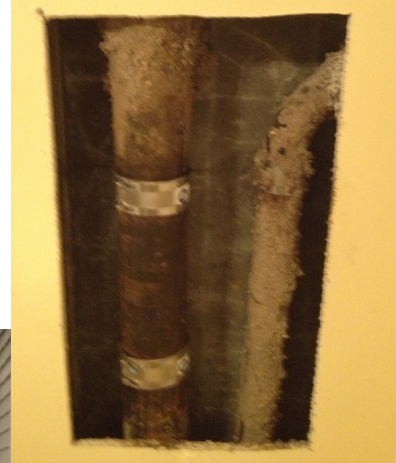
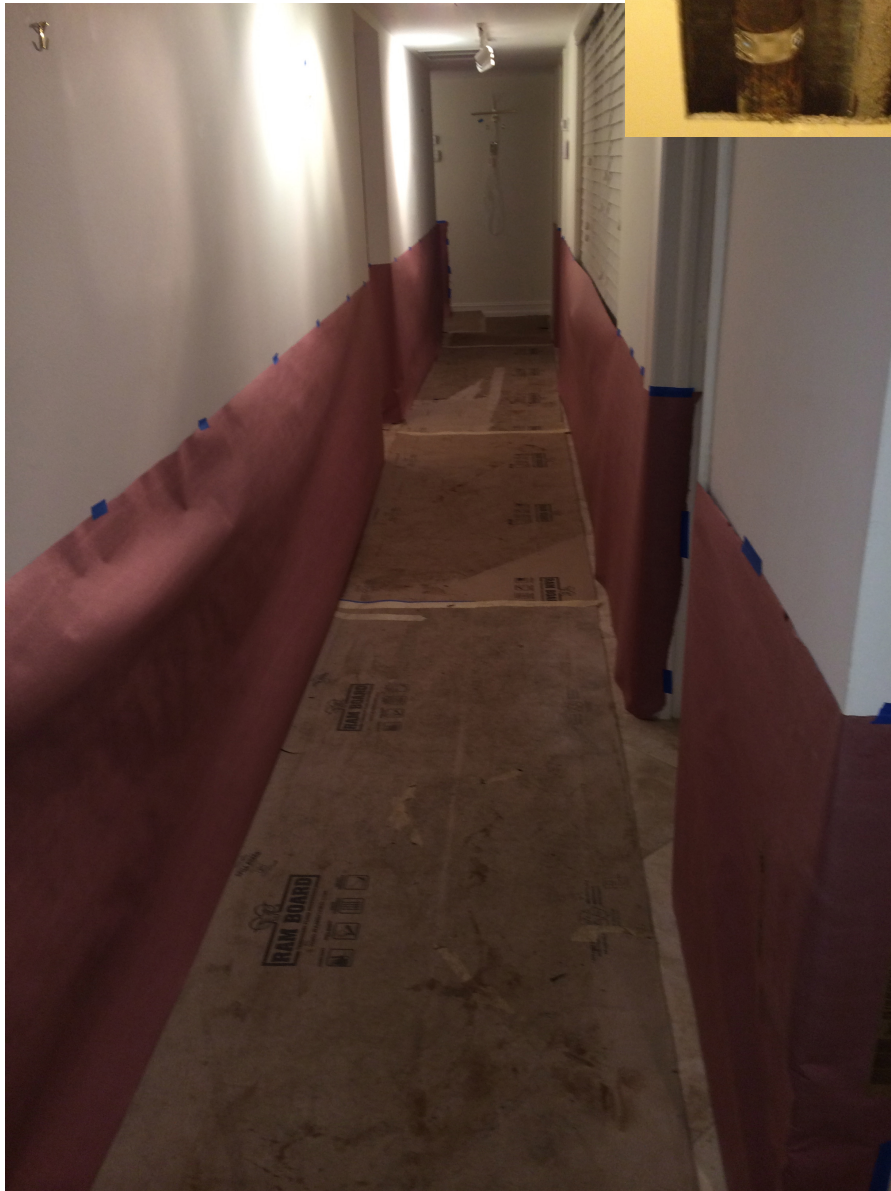
Blue Works Safe Guards Work Areas to Minimize Resident Disruption & Maintain Work Areas. Blue Works Typically only Needs One Access Point Per 10 Floors, to Clean a Stack, with the Equipment Connected at the Base, Typically in the Parking Garage.

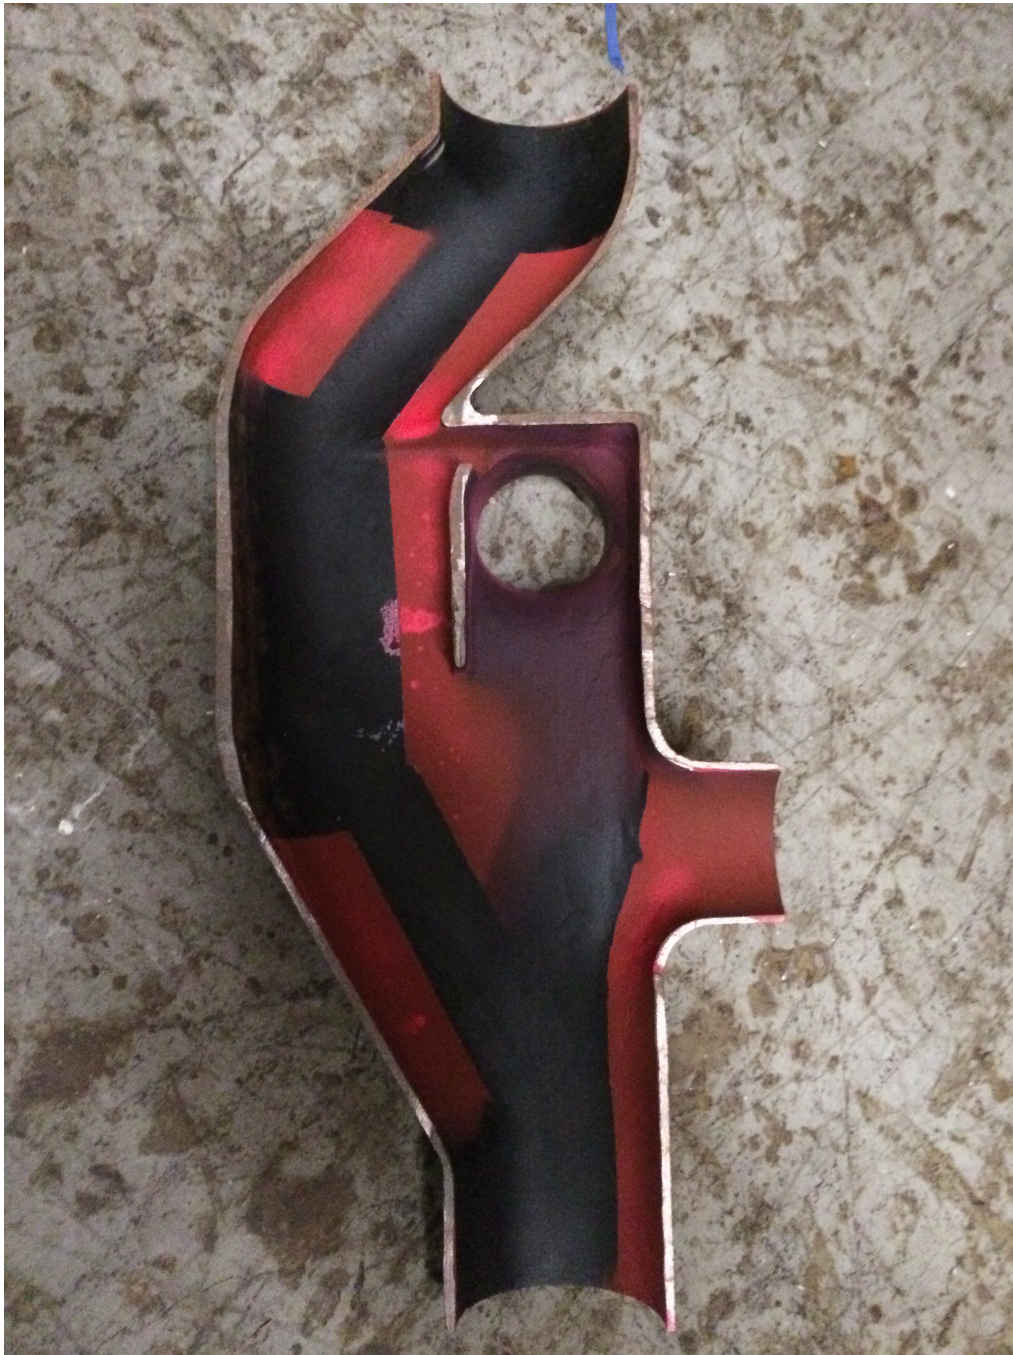
Blue Works understands these systems and their design better than anyone else, here is a Cut-Away from a Solvent Device, the areas in Pink make traditional cleaning of the system more than difficult, and create areas for Pipe Occlusion, Reducing Positive Air Flow & Accelerating Pipe Debris Buildup.

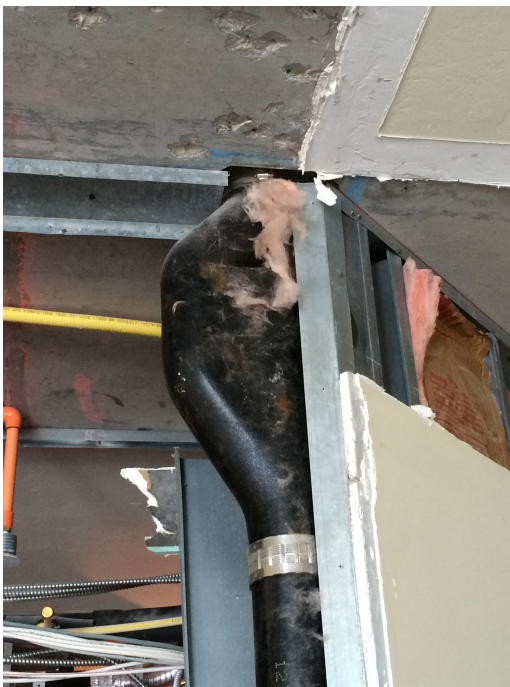
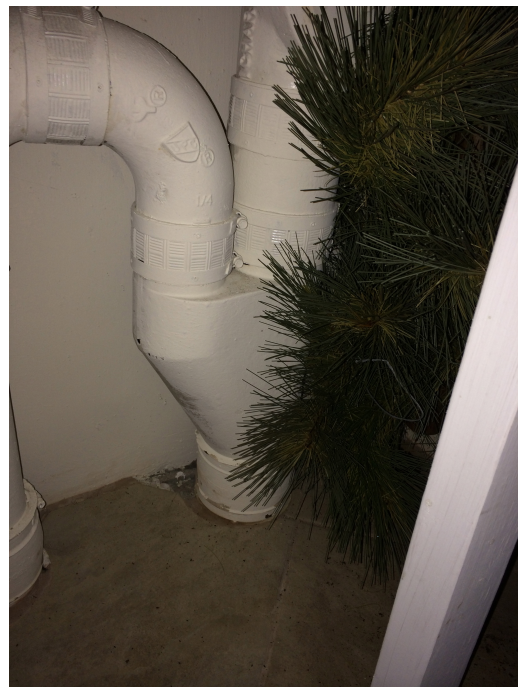
Below are the Soyent Devices as they are installed in a Building, Typically each floor has the unit on the left (Areator), while the device on the right (De-Areator) is installed at the Base of the Stack, and sometimes at Transitions near the Roof. Page Bottom are few Examples of Schematics of Soyent Buildings Isometrics

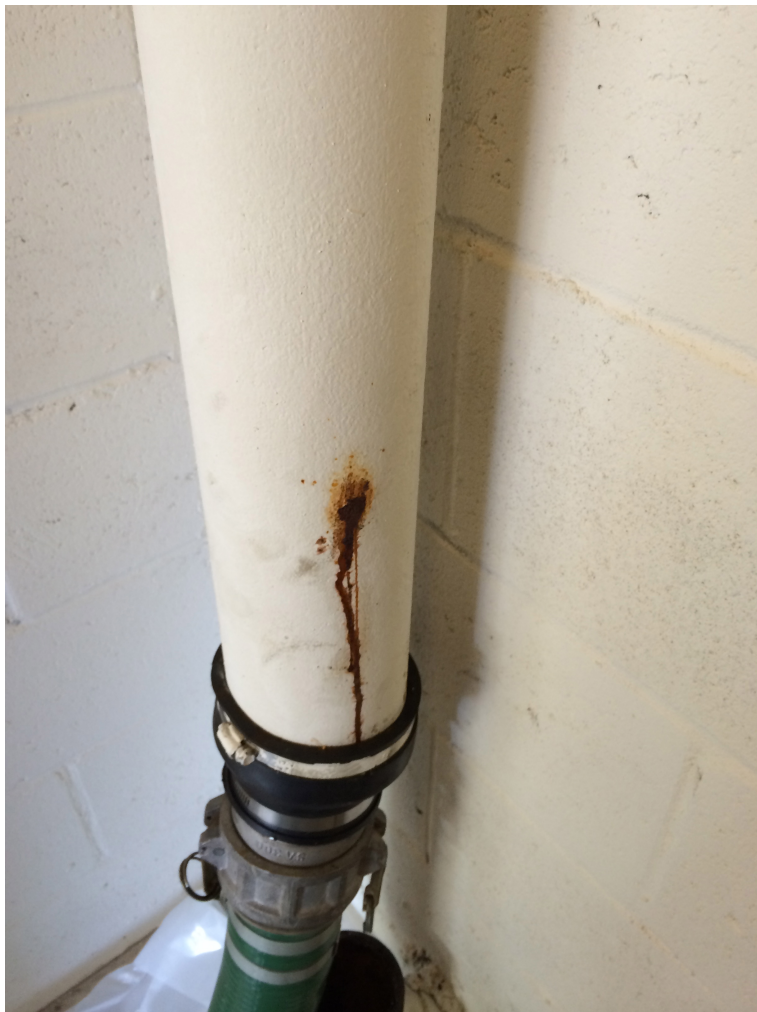
The Bigger Problem is Accelerated Pipe Cracking, or Stress Corrosion Cracking in Cast Iron, Due to Debris in the System, Below is an Example of a 10 Year Old Building Experiencing Failures & Leaks in their Sovent Cast Iron Piping. The Following Pages Identify the debris sitting on the interior of the Cast Iron Piping directly causes these Failures of the Cast Iron Piping. The only way to stop this degradation is to clean the Piping to Original Operating Diameter, once the Piping starts to leak, it will have to be replaced, or CCIP Lined, which is dramatically more expensive, a monumental undertaking.

An analysis was initiated regarding the failure of 2-inch and 3-inch cast iron drain pipes. The pipes were from a 258-unit complex that was reportedly built in at least two phases. The drain pipe system was stated to have been 30 years old. It was reported that the drain pipes had been installed crooked, bent, not supported, and not clamped. A sampling of drain pipes was removed and submitted to the Laboratories for examination and testing. It was reported that cracked drain pipe from first floor units had previously been replaced due to cracking. The failed pipe involved longitudinal splitting or cracking. The analysis included visual and microscopic examinations and digital and dimensional documentations, Scanning Electron microscopic and Energy Dispersive spectrographic analysis of the fracture surface, and chemical analysis and metallographic examination of the base material. The objective of the analysis was to determine the cause of the failures.

In multiple level units, the first floor drain pipes commonly sustain heavier corrosion and greater potential for cracking due to longer exposure to corrosive chemicals/media, heavier corrosion product buildup, and greater stress due to the corrosion products and the vertical weight of the drain pipe system.

The cast iron pipes submitted failed prematurely due to: varying degrees of residual stress, corrosion which decreases wall thickness and can induce hoop stress, microstructure variances, and apparent installation deficiencies that would increase pipe stresses. Thus, it is concluded that the propensity for failure of the remaining cast iron drain pipe would differ based on these variables.

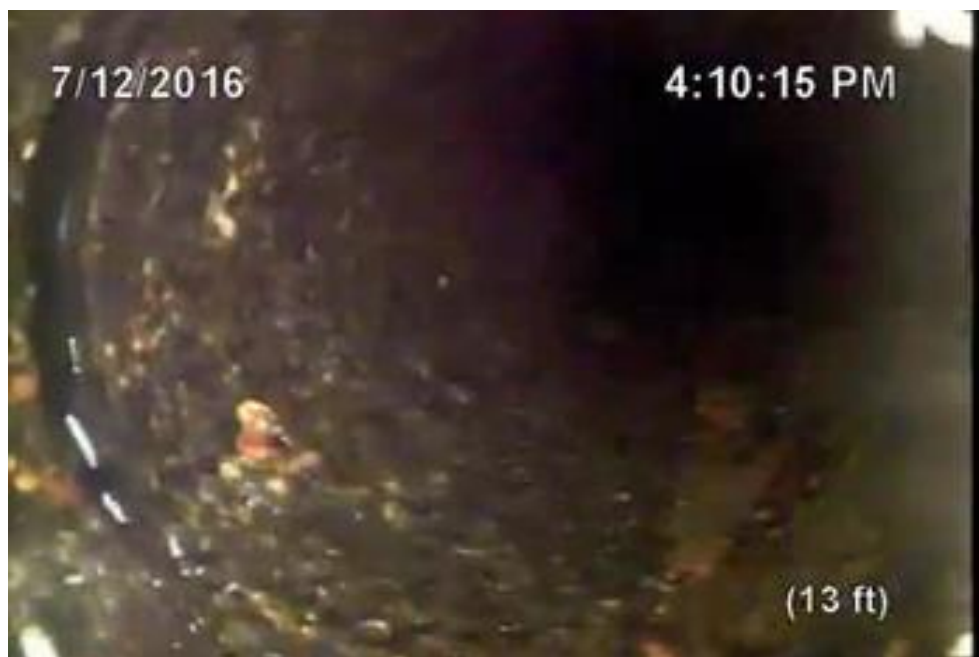
The Blue Works Difference: **Before Cleaning** / **After Cleaning**, Same Pipe, Same Place, (Top) Sovent Piping Choked Off to Less than 2", (Below) Sovent Re-Opened to 4" in Diameter Approx. 1 Hour Later, 1 Access Point, No Gimmicks, No Tricks, No Maybe's
